Bulletin No.: PIP5330A

# Service Bulletin

Subject: Coolant Loss And/Or Coolant Odor

Models: 2015-2017 Cadillac Escalade

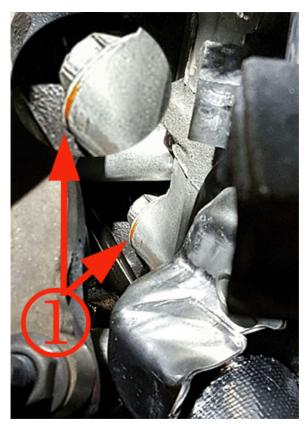
If the coolant is low pressure test the cooling system looking for leaks at the outer head bolts. See below

If a leak is found the head with the concern will need to be replaced.
